Plant Risk Assessments Report for: Isuzu NH Series NLR 200 Tipper

Prepared by:	Australian Risk Services (ARS)
Owner:	Isuzu Australia Limited
Document Number:	IZU-P143
Issue Number:	1
Issue Date:	August 2014
Review Date:	August 2015

ISUZU NH SERIES NLR 200 TIPPER

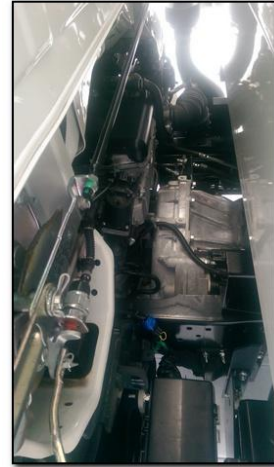
Risk No. 1

Inadequate inspection intervals leading to mechanical failure or un-roadworthy condition.

- The Isuzu NH Series NLR 200 Tipper must be checked for fitness for purpose before and after every job.
- Before use inspect the relevant equipment. Develop a relevant “Vehicles/Equipment/Plant Daily/Weekly Checklist” that ensures the roadworthy condition of the vehicle before operation. All defects must be reported and rectified before operating equipment. Report faults to Management for repair. Do not use unsafe plant. Operators must tag unsafe plant with a “Do Not Operate Tag”.
- Operators must be trained in conducting vehicle inspection.
- Vehicle must be regularly serviced according to manufacturer specifications.
- Always wear appropriate PPE when performing minor maintenance. Always ensure the vehicle is appropriately isolated when conducting inspections and that all risks relating to raised truck cabin or vehicle requiring chocking of wheels is complied with prior to inspection.

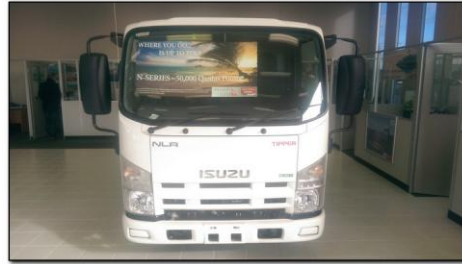
Risk No. 2

Driving into bystanders

- Fit revolving amber hazard light to operate automatically when P.T.O is **“ENGAGED”**.

- Licensed and competent operator
- Complete Risk Assessment (RA) or Hazard Assessment for tipper operation.
- If assistance is required when reversing vehicle or into a narrow space it is recommended that an observer is used to provide guidance and instructions to the driver in respect to maneuvering vehicle. The driver and observer should agree on communication protocols before engaging in activity. The observer is to position if themselves a safe distance from the vehicle within view of the drivers R.H side rear view mirror.

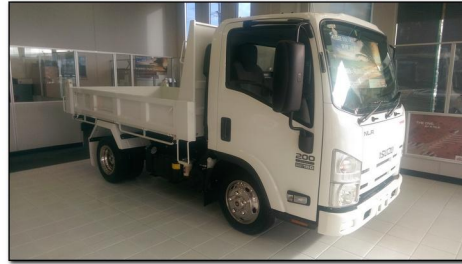
Risk No. 3

Striking low level branches and objects

- Ensure No Go Zone has been established and adhered to for safe clearance of overhead electrical wiring (refer to Regulatory website for details).
- Ensure spotter is used when required.
- Ensure area is clear of obstructions and Isuzu NH Series NLR 200 Tipper has sufficient room to carry out required task.
- Be alert. Look up as well as down.
- If unfamiliar with area or task being performed, complete Risk Assessment (RA) or Hazard Assessment
- Fit raised body height and lowered body height clearance decals in view of operator station in accordance with AS 1319.

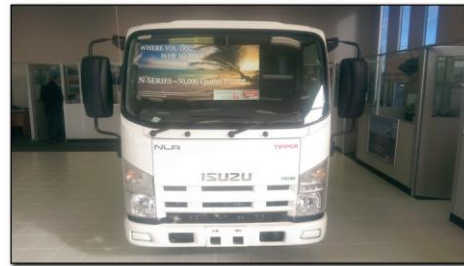
Risk No. 4

Electrocution from overhead power lines

- Complete Risk Assessment (RA) or Hazard Assessment
- Do not operate where an electrical hazard exists
- Request "tiger tails" from electricity company as necessary.

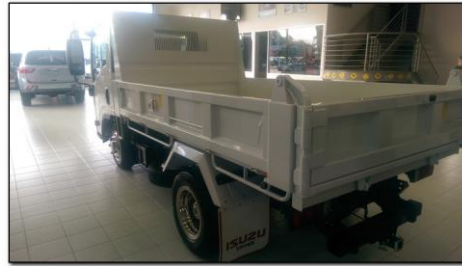
Risk No. 5

Unexpected movement of plant with or without operator

- Pedestrians and operator being struck
- Damage to plant and equipment

- Fit **"HOIST SAFETY STAND MUST BE FITTED UNDER TIPPER BODY & LOCKED INTO PLACE AT ALL TIMES WHEN TIPPER IS TO BE LEFT IN RAISED POSITION"** signs to both sides of tipper body.
- Fit **"DANGER, CRUSHING ZONE DO NOT STAND UNDER RAISED TIPPER BODY PRIOR TO FITTING & LOCKING SAFETY STAND"** warning signs.
- Fit **"DANGER, KEEP CLEAR OF TIPPER TAILGATE"** signs to rear and sides of tipper body.
- Fit **"DO NOT RAISE TIPPER ON SOFT OR UNEVEN GROUND AS OVERTURNING IS POSSIBLE"** warning sign to tipper control station.
- Complete site hazard assessment.
- When conducting maintenance or positioning vehicle on slopes, ensure wheels are chocked and that handbrake and gear is in appropriate parking position.

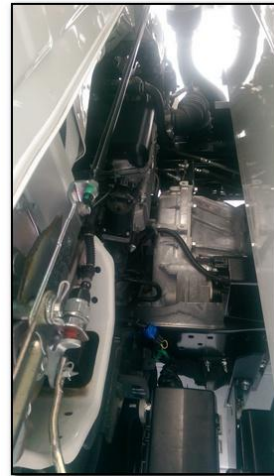
Burns

- Fit **"DANGER, HOT SURFACES"** decal in proximity to exhaust areas in accordance with AS 1319.
- PPE gloves should be worn.

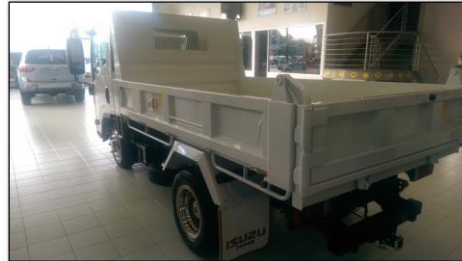
Risk No. 9

High pressure fluid release

- PPE clothing eye protection goggles
- Pre-start checks on vehicles including hoses
- Hydrocarbon or Chemical Spill Kits must be carried as appropriate to vehicle operations
- Ensure all spills are cleaned up immediately using appropriate spill kit, block off drains, ensure used spill kit material is removed from site and placed in Depot Contaminated Waste Bin and that spill kit contents are replaced.
- Report spill to manager and complete Incident Report if spill enters drain or >1L
- Carry out full service to hydraulic system and reservoir at required intervals as per manufacturer's specifications.

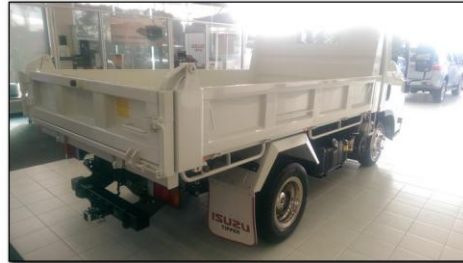
Risk No. 12

Loads falling off back of truck

- Ensure vehicle is not overloaded in accordance with manufactures' specifications.
- Secure all loads appropriately in vehicles ensuring loads are stored within tray / tipper body area.
- Ensure that items are stored appropriately in truck cabins.
- Ensure all items are secured in accordance with load restraint guidelines.
- Load binders, straps, chains and load dogs are to be inspected before use.
- Ensure no loose items are within the passenger area as they may become projectiles in the event of an accident.
- Ensure hand tool e.g. rakes, shovels are restrained to prevent them falling from vehicles

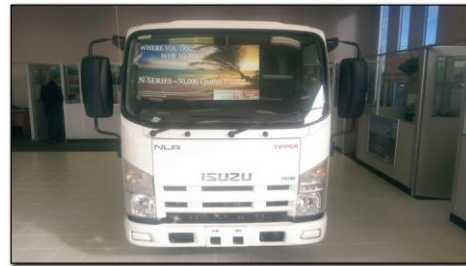
Poor weather conditions

- Trained and competent operators.

- Fit fog lights and day time running lights in accordance with local road regulations.

- Operators should reduce their speed in adverse conditions; thus the margin for error is greatly reduced assisting drivers in recovering from a mistake or wrong judgement. (eg required stopping distances)
- Always remain aware of other vehicles around you; high winds are more problematic for drivers of trucks and large vehicles,
- Be mindful in high winds when moving from a protected area to an unprotected area, or when approaching/passing large vehicles to reduce your speed and correct you're steering
- Stay alert for slippery areas and debris on the road.
- Make sure you have a pair of sunglasses in your vehicle in case of bright sunlight.

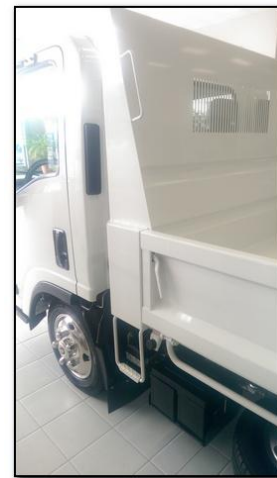
- Trained and competent operators
- Access steps on truck body

- Fit serrated edge step treads with minimum 100 mm treads to access steps on tipper body. Steps must be fitted with SAA 59 ergonomic standard & AS 1657 compliant handrails and grab handles (slips, strains and falls protection).
- Fit static line system to top tipper body access steps and introduce fall restraint and safety harness P.P.E. system to work procedures.
- Remove existing non-compliant tipping body access steps (working at heights, falls injury risks, Introduce fall prevention systems to work process).

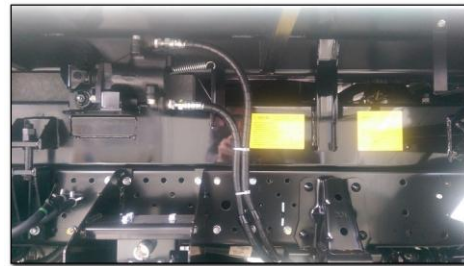
Risk No. 16

Hydraulics can lower without warning

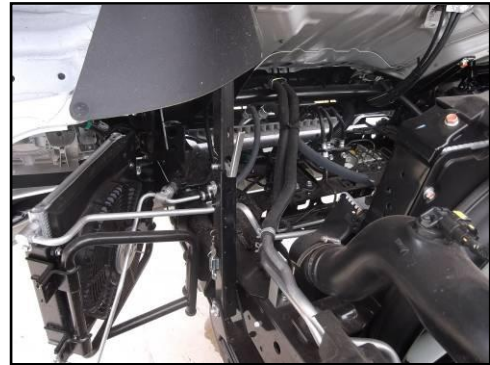
- Trained and competent operators
- Safety prop fitted

- Paint cabin safety stand & locking system assembly **yellow** or **red** (**Colour of Safety system must be clearly discernible from background**) & fit instruction sign in close proximity to safety stand.

- In the event of truck being jacked off the ground, multiple stands (load rated to vehicle GVM) are required to support fully loaded truck so that in the event of single stand failure, vehicle will not fall.

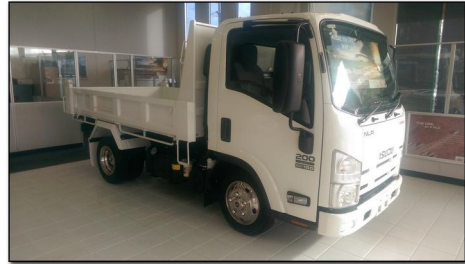
Risk No. 18

Plant tipping or rolling over and/or operator being ejected

- Tipper to be driven on public roads in accordance with local Road Authority and regulations.
- Driver and passengers must always wear a correctly adjusted seatbelt.

- Do not exceed the maximum allowable load of the tipper.
- All loads must be evenly distributed and correctly secured to the tipper.
- Travel at speeds appropriate for the ground conditions e.g reduce speed on gravel, dirt, winding, slippery or bad roads.

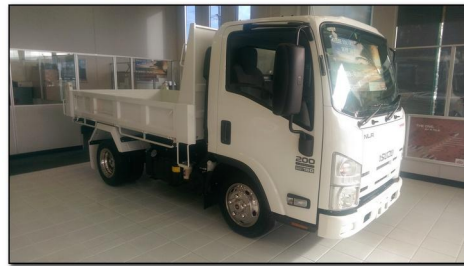
Risk No. 19

Lack of capacity for plant to be slowed, stopped or immobilized.

- Do not exceed the grade ability of the tipper.
- Braking distances vary depending on road conditions. Travel at speeds appropriate for the ground conditions to allow for safe braking distance e.g. reduce speed on congested, unsealed gravel, dirt, winding, slippery or bad roads.
- When driving down along slope, ensure the exhaust brake is engaged. Using the exhaust brake in conjunction with the service (foot) brakes minimizes the likelihood of brake failure caused by excessive use of the service brakes.
- Ensure wheels are chocked when parking on slopes, uneven or unstable surfaces.

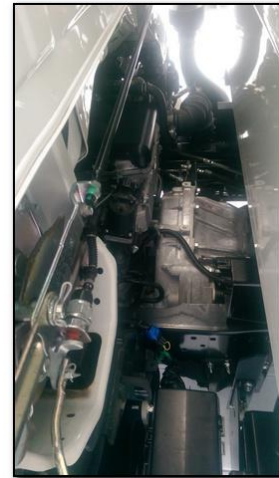
- Trained and competent operators

- Fit AS 4024 compliant, fixed type guarding to rotating fan blade and drive belts on engine as far as practicable.

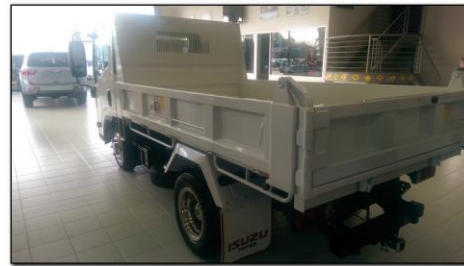
Risk No. 22

Strains when loading or unloading tipper manually

- When manually loading/unloading, follow correct manual handling procedures and use a two man lift where required.
- Follow correct manual handling techniques.
- Vehicle must be stationary before entering/exiting
- Prior to exiting vehicle ensure the handbrake is fully engaged and in first gear in manual trucks.
- Check traffic conditions before loading or unloading material.
- Ensure operator has a stable balanced posture at all times that reduces the risk of falling when loading unloading. Operators are not to load or unload when risk of falling off side of tipper body.
- Do not stand in proximity of the tipper when being unloaded manually. Ensure no personnel can be struck when loading or unloading.

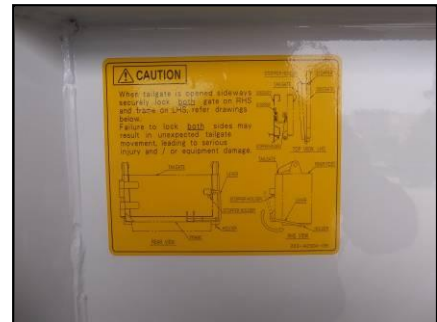
- Trained and competent operators
- Instruction sign fitted

- Fit "**CAUTION - CRUSH AND PINCH POINT**" to both sides of tailgate in accordance with AS 1319.
- Fit reflective tiger tape to edges of tailgate and tipper body.
- Conduct pre-start check on tailgate locking mechanism to ensure correct operation.
