Plant Risk Assessments Report for: Isuzu NH Series NPR 200/275 Tipper

Prepared by:	Australian Risk Services (ARS)
Owner:	Isuzu Australia Limited
Document Number:	IZU-P138
Issue Number:	1
Issue Date:	August 2014
Review Date:	August 2015

ISUZU NH SERIES NPR 200/275 TIPPER

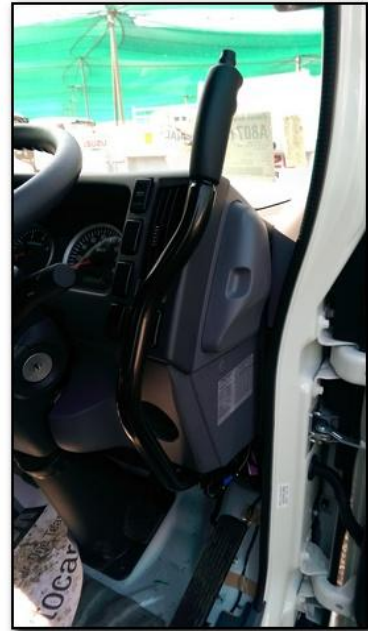
- Pedestrians and operator being struck
- Damage to plant and equipment

- Trained competent operator
- Machine has a park brake
- Tipper safety stand fitted and painted yellow.
- Safety stand instruction sign fitted

- Re-position **Hoist control** away from operator entry and exit path to prevent accidental crushing from lowering and raising of tipper body. Or
- Fit 2 stage release locking system to hoist control & mechanism to prevent accidental selection from neutral position.
- Fit tailgate lock safety warning audible and visual alarm system to cabin. (Warning system must warn operator tailgate is not locked.)

- Fit **“HOIST SAFETY STAND MUST BE FITTED UNDER TIPPER BODY & LOCKED INTO PLACE AT ALL TIMES WHEN TIPPER IS TO BE LEFT IN RAISED POSITION”** signs to both sides of tipper body.
- Fit **“DANGER, CRUSHING ZONE DO NOT STAND UNDER RAISED TIPPER BODY PRIOR TO FITTING & LOCKING SAFETY STAND”** warning signs.
- Fit **“DANGER, KEEP CLEAR OF TIPPER TAILGATE”** signs to rear and sides of tipper body.
- Fit **“DO NOT RAISE TIPPER ON SOFT OR UNEVEN GROUND AS OVERTURNING IS POSSIBLE”** warning sign to tipper control station.
- Complete site hazard assessment.
- When conducting maintenance or positioning vehicle on slopes, ensure wheels are chocked and that handbrake and gear is in appropriate parking position.

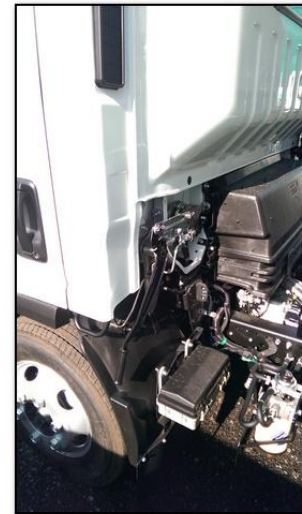
- Trained and competent operators
- Safety prop fitted

- Paint cabin safety stand & locking system assembly **yellow** or **red** (**Colour of Safety system must be clearly discernible from background**) & fit instruction sign in close proximity to safety stand.

- In the event of truck being jacked off the ground, multiple stands (load rated to vehicle GVM) are required to support fully loaded truck so that in the event of single stand failure, vehicle will not fall.

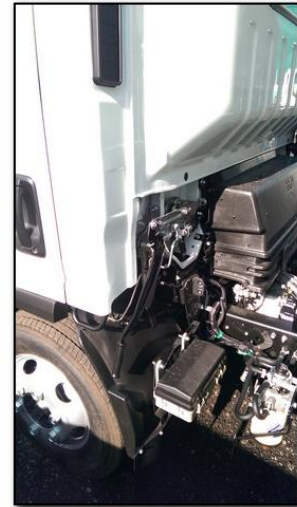
- Trained and competent operators

- Fit AS 4024 compliant, fixed type guarding to rotating fan blade and drive belts on engine as far as practicable.
